Manhole Inspection Summary

Manhole # S51K__027MH

Insp Date: **4/15/08 1:29 PM**

Location Address: **534 fleet st**

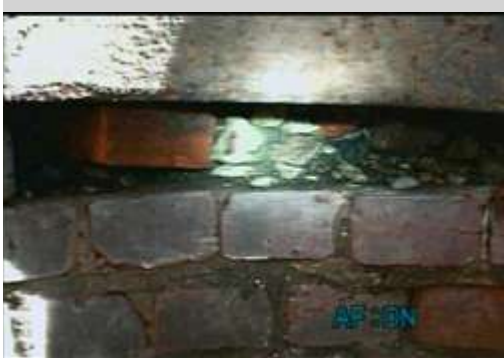
Defect 2

Condition: ☐ Sound ☐ Cracked ☐ Root Intrusion ☒ **Loose Brick** ☐ Deteriorated

chimney cond loose bricks

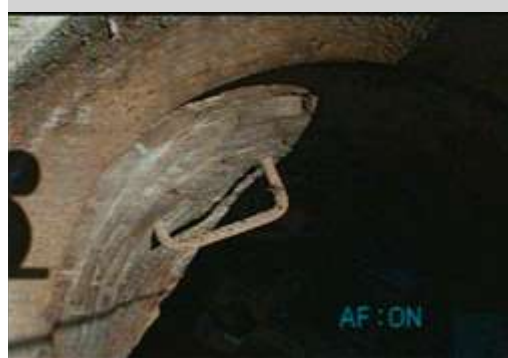
Defect 1

Steps Count: **2** Missing: **0** ☒ **Corroded**

steps

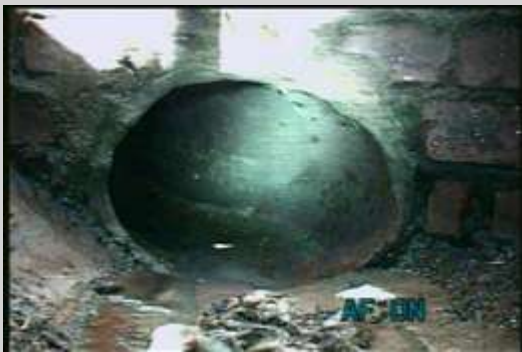
12 O'Clock Outflow

8 in. Circular Gravity Sewer
Pipe Out @ 12 O'Clock

Pipe Material: **Clay** ☐ Pipe Lined

Invert Depth: **5.66** (ft.) Flow Characteristics: **None**

Infiltration: **None** Pipe Seal Cond: **Unknown**

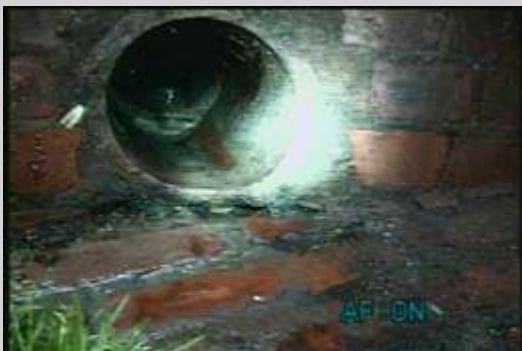
4 O'Clock Inflow

8 in. Circular Gravity Sewer
Pipe In @ 4 O'Clock

Pipe Material: **Clay** ☐ Pipe Lined

Invert Depth: **5.50** (ft.) Flow Characteristics: **Slow**

Infiltration: **None** Pipe Seal Cond: **Unknown**

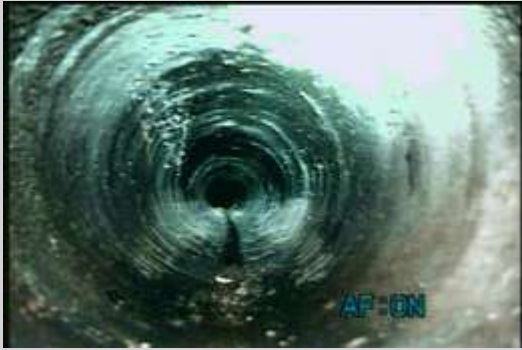
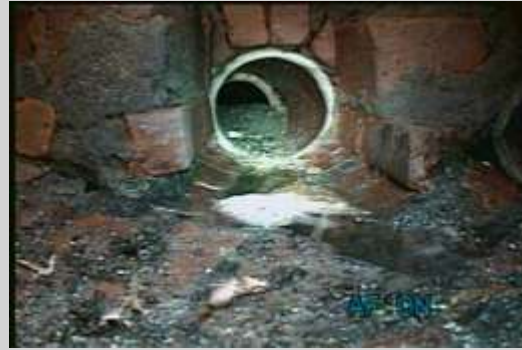
6 O'Clock Inflow

Pipe In @ 6 O'Clock

Drop In @ 6 O'Clock

Drop: **Inside** **Direct**

Drop Condition: **Open**

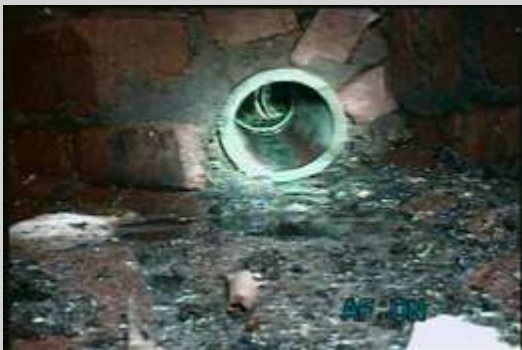
7 O'Clock Inflow

Pipe In @ 7 O'Clock

Pipe Material: **Clay** ☐ Pipe Lined

Invert Depth: **5.30** (ft.) Flow Characteristics: **None**

Infiltration: **None** Pipe Seal Cond: **Unknown**
